QA-74

Joseph Quimby Farm  
Centreville vicinity  
Private

## INVENTORY FORM FOR STATE HISTORIC SITES SURVEY

Joseph Quimby Farm

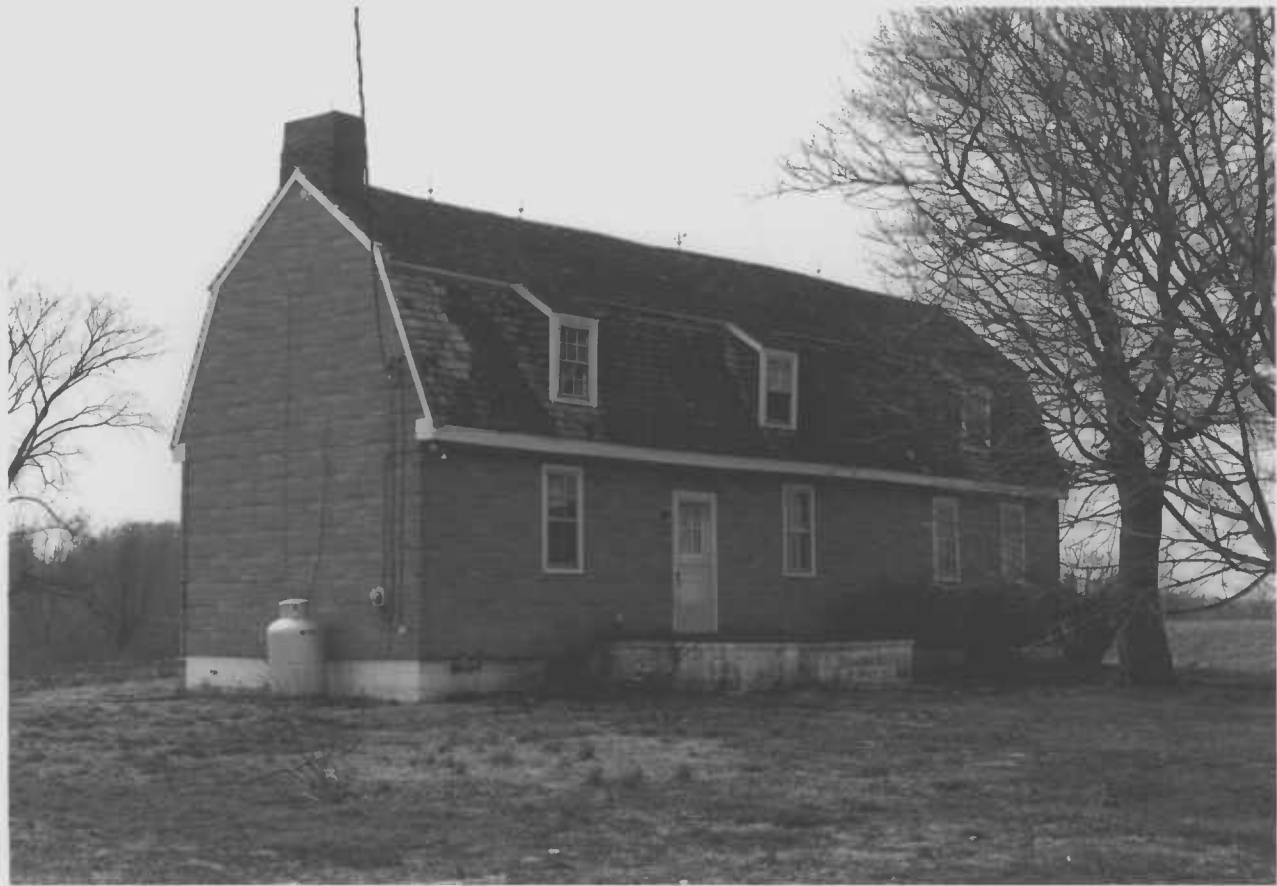
QA-74

The principal facade faces north, toward White Marsh Road. There is a door near the center of the original section flanked by a single 6/6 window on each side. Two shed roof 6/6 dormers are located above each first floor window. There are two 6/6 windows on this facade of the addition,

shifted off-center toward the east. A single shed roof 6/6 dormer is centered on the second floor. There are no openings or early detail on the east gable. A flush brick chimney rises at the center of this end of the house. The original fenestration on the rear or south facade has been disrupted by the now demolished wing. An original door opening with modern door is located to right of center, with a modern kitchen window to the right and a single shed roof 6/6 dormer above the kitchen window. There are two 6/6 windows in the south wall of the early addition, and two 6/6 shed dormers. A circular depression in the ground near the east end of this facade appears to identify the location of an old well. On the west gable, there is a modern exterior door at the south corner, and a 6/6 window to the north. A single 6/6 window is centered on the second floor.

Joseph Quimby Farm  
Centreville vicinity  
Orlando Ridout V 1980  
Front facade from Northeast

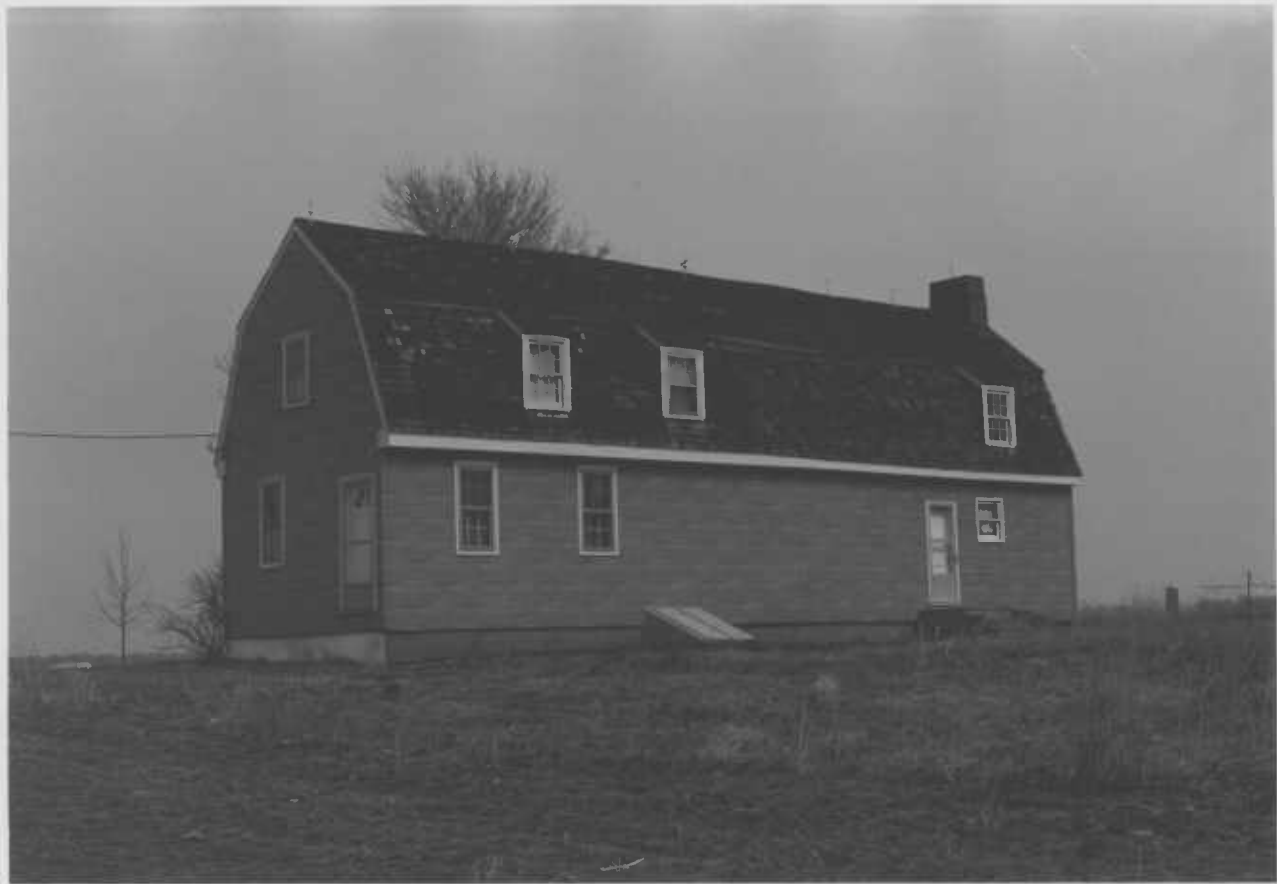
QA-74

Joseph Quimby Farm  
Centreville vicinity  
Orlando Ridout V 1980  
Rear facade from Southwest
